## ▶ CASE STUDY: FLOOD APPLICATION

### Keystone Stands Up to El Niño's Rage!

- ▶ **PROJECT:** Peter's Canyon Wash
- LOCATION:** Irvine, California
- PRODUCT:** Keystone Standard Units Modified for flood control channel revetment
- SQUARE FOOTAGE:** 32,000 sq. ft. (approx.)
- GENERAL CONTRACTOR:** Griffith Co. Santa Ana, California
- ENGINEERING CONSULTANT:** John M. Tetterer & Assoc.
- KEYSTONE REPRESENTATIVE:** Stable Earth Systems, Inc. Santa Ana, California

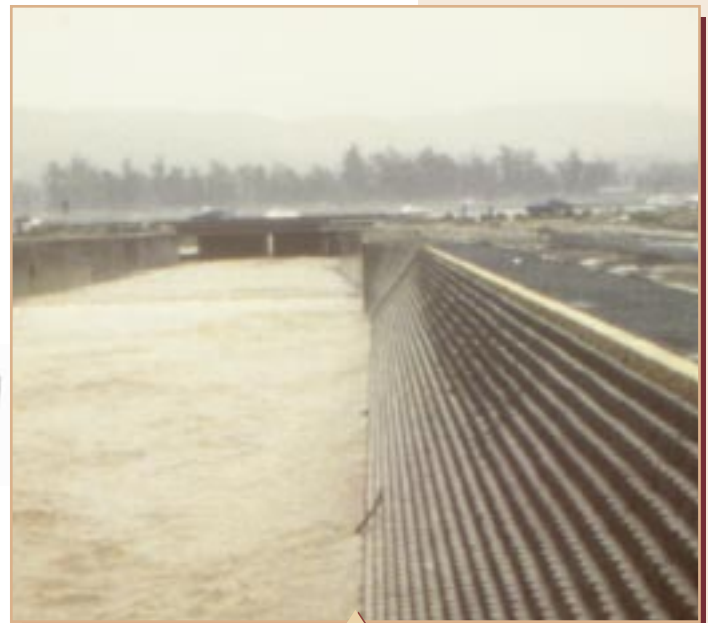
*Phase I of Peter's Canyon Wash is complete.*
